STATION, RADIO, A13

TECHNICAL HANDBOOK - MISCELLANEOUS INSTRUCTION

TELECOMMUNICATIONS
F 149 Misc Instr No 2

SUB-TITLE: Undersized carrier locating dowel holes on Transmitter-receiver, radio, A13 (TRA13)

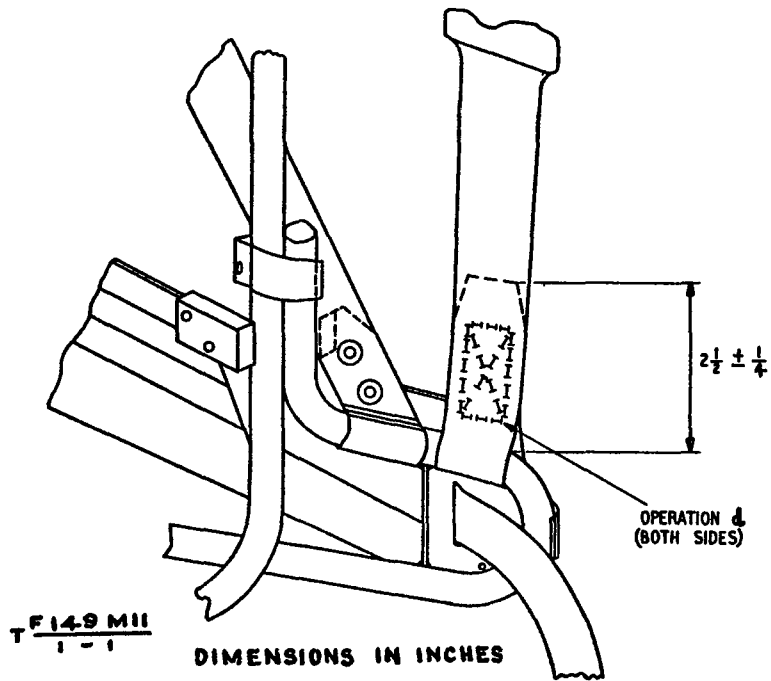
Fig 1 - Temporary modification assembly

- a. Cases of the canvas shoulder straps breaking away from the carrying frame have been reported. This failure is due to the rusting of the four screws, holding the backrest to the frame, which rot the canvas between the backrest and frame.
- b. This instruction details the action to be taken as a temporary measure, in operational areas where high humidity is likely to cause this failure or where the failure has already occurred.
- c. It should be noted that carrying out this instruction causes the straps to become part of the frame whereas they are catalogued as part of the webbing. In current production, provision is made for the straps to be fitted in the same position as detailed below but removable from the frame (see Fig 2).

- a. Remove the four screws and washers securing the padded waist support to the frame assembly and retain for re-fitting.
- b. This action releases the ends of the buckled shoulder straps, (5340-99-103-7359) from between the waist support and the frame.
- c. Leaving the ends of the straps free, reverse operation (a) after applying a thin coat of varnish DEF 32 (H1/8010-99-943-3454) or similar to the screw threads.
- d. Wrap the end of the shoulder straps around the frame, positioned round the curved part of the frame in front of the welded plate, and secure by stitching using rotproofed thread, or by suitable rivets and washers, (see Fig 1).

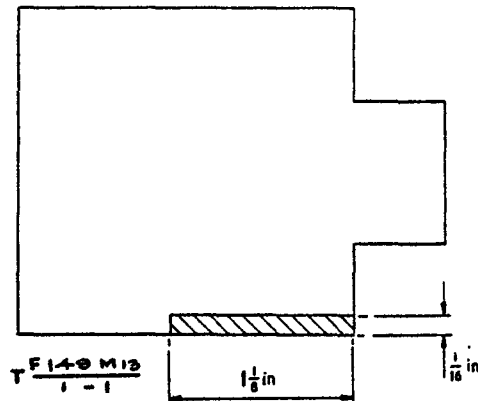
Fig 1 - Board 16, modification

During production, under conditions of adverse tolerance build-up, instances have occurred of the panel, electronic circuit (5820-99-101-9807), board 16, fouling tagstrip TSC. This instruction details the procedure to be adopted when replacing panels on which this problem is encountered.

If it is found on replacement of board 16 that it fouls tagstrip TSC, refer to Fig 1 and remove the shaded area indicated. Apply a thin coat of varnish insulating (8010-99-943-3454) to the cut edges of the board.

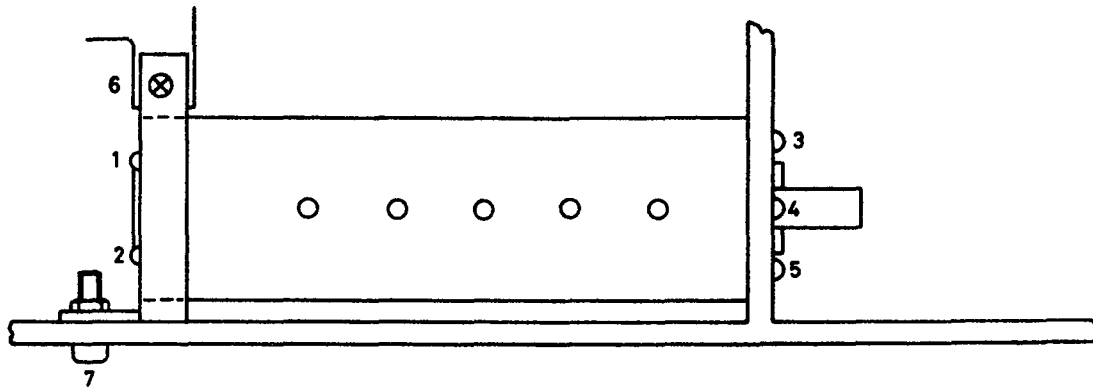
Fig 1 - Location of screws

It has been found that the method of fitting a gang capacitor in an equipment can distort the vanes. This instruction details the action to be taken when replacing the main gang capacitor.

- a. Locate the rear mounting bracket on the gang capacitor and insert screws number 1 and 2 leaving them loose.
- b. Insert the gang capacitor into the front retaining hole and insert screws 3, 4 and 5 just taking up the slack. Ensure the gang is located correctly and tighten screws numbered 3, 4 and 5 sequentially.
- c. Insert screws numbered 6 and 7 leaving them loose.
- d. Lightly hold the rear mounting bracket simultaneously against the rear of the gang and the chassis at the positions of screws numbered 6 and 7 then tighten these screws.
- e. Finally tighten screws numbered 1 and 2.
