A fault with the C11 Tx

Richard Hankins, G7RVI and Mike Hazell, G1EDP

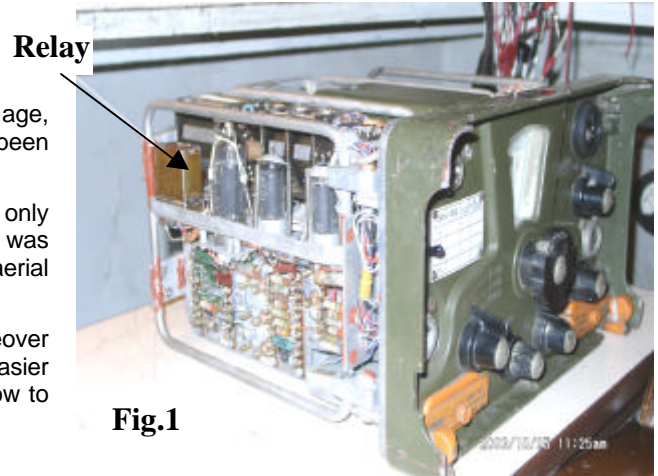
Fig.1

The root of the problem is dirty contacts in the Tx/Rx aerial changeover relay¹. And the only solution is to clean those contacts – but that is easier said than done, as the relay is a sealed unit. This article describes how to go about it, and also provides what we believe will be a long term fix.

1. Locate the relay (Fig.1) and remove it from the set, making a note of the various connections as you remove them.
2. Once you have the relay in your hands, you will see that it is varnished all over. Under the varnish can be seen two retaining bolts on the top. On the bottom there is a metal retaining ring, which holds the relay into the case – this base ring is also soldered to the case.

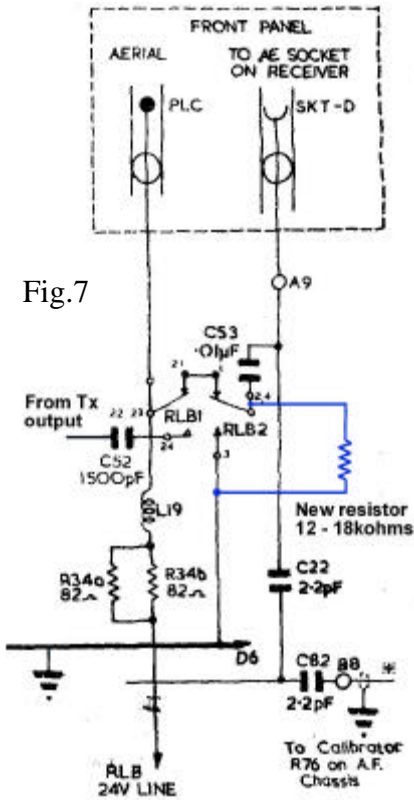
It may be noted that only the relay contacts that make on receive actually have a problem: the contacts that carry the Tx output do not develop this problem. Why? The reason is that on transmit a considerable current flows through the relay contacts – into a 50 ohm load, with 50W output, the current is 1 amp r.m.s. This is many times more than is needed to keep the contacts completely clean.

The same does not apply to the receive contacts – the current they pass is very small indeed, and consequently sooner or later the crud builds up. This takes a good while, as the relay is sealed from dust, grease and other contaminants in the air, and probably explains why this problem did not show up while the C11 was in service, as far as we know.

current to keep the contacts clean. 1 – 2mA DC is generally reckoned to be enough. Conveniently, the relay changeover contact does have 24V DC on it, and thus the addition of a 12 – 18kohms resistor to ground is all that is needed. This resistor has no effect on the RF signals carried by the relay. See Fig.7 shows the circuit of the modification, and Fig.6 a picture of the resistor in place.
