The VMARS Newsletter Issue 34

OSCIllations! Richard Hankins G7RVI

A14HP low frequency oscillation

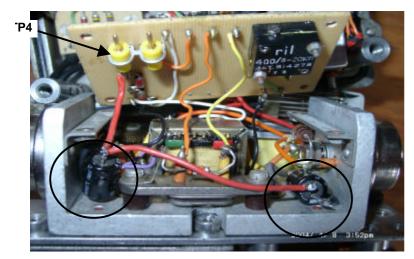
Modulator assembly

This picture (left) shows the A14 amplifier after being taken apart to allow fitting of the two capacitors., within the modulator assembly. You might manage the job without this level of disassembly, but that's up to you!

The front panel assembly is removed from the rest – take great care with relay RLA, as its contacts are unprotected and easily bent.

Unfortunately, there is nowhere to fit a typical 470uF 25V capacitor in the very confined space available in the amplifier, so I used two 220uF 25V capacitors in parallel. You do not need to have higher voltage capacitors, since the maximum voltage on the modulator is 24 volts. This solution appears to have no unfortunate side-effects, and I recommend it to other users of this set.

The picture on the right shows the two 220uF capacitors (ringed) being crammed into two tiny bits of spare space, inside the modulator. They are connected in parallel, negative to chassis (collectors of VT2 And VT3) and positive to the supply rail at TP4.
