Special Operations Executive – The B2 spy set *Ken Brooks G3XSJ*

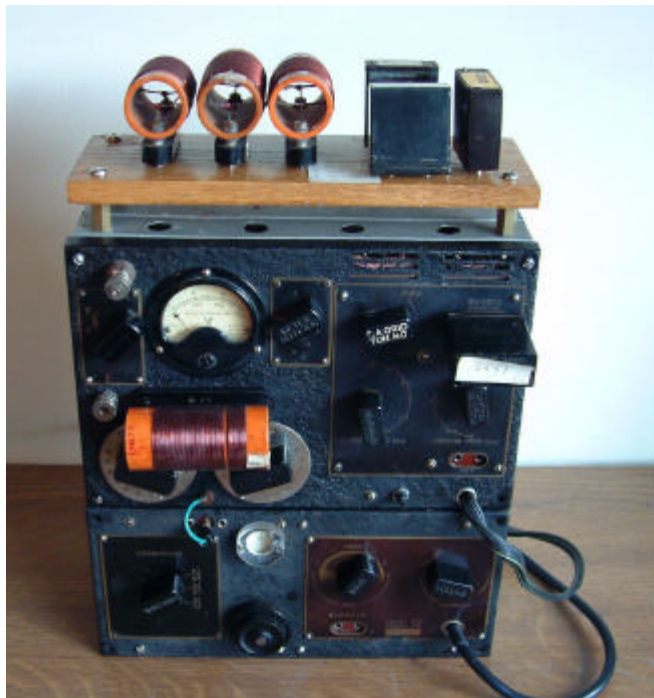
B2 transmitter and receiver. The coil and crystal stowage was added by the previous owner and although not original adds visual interest.

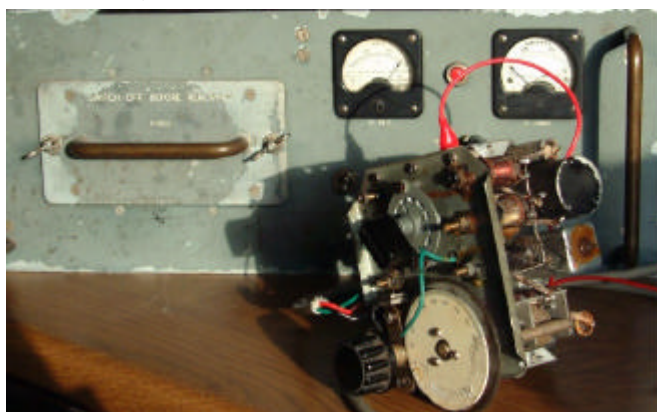
Testing the receiver RF unit.

RF unit, as unlike the IF unit which is one component layer deep, the RF unit is three layers deep and the lowest layer where some components were to be replaced is extremely hard to access. These problems were put to one side whilst more immediate repairs were made.

Next, the two modern postage stamp trimmers for bandspreading were removed together with two paxolin trimmer mounting panels. Fortunately two of the original style orange trimmers were found in a scrap Gee RF unit to replace them. With the trimmer panels out of the way deep heart surgery was performed around the bandswitch where most of the earlier modifications had taken place, and comprised fitting replacement silver mica capacitors and reinstatement of wiring in the oscillator section.

Although the circuit is relatively straightforward the mechanics of replacing these parts was what might be called "challenging", needing tweezers and a steady hand to fit and solder components in places that are almost completely obscured from view by surrounding parts. The trimmer panels were refitted this time with the correct countersunk fasteners sourced from the junk box. Again this was a fiddly operation as they would initially have been secured early in the assembly sequence in the factory. All this more or less completed the RF unit. With the mixer circuit temporarily disabled, power was applied to check the oscillator. A quick check confirmed it was working on each of the three bandswitch positions.

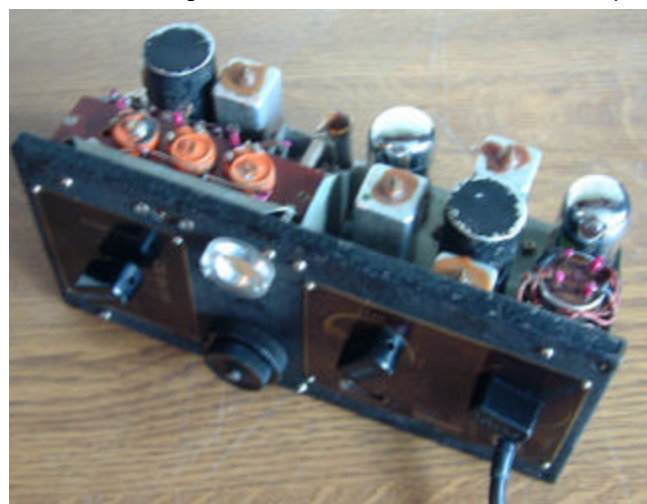
Completed B2 receiver following repairs.

A grey plastic jack socket had been added to the front panel in addition to the original headphone connector. This looked out of place and although I was keen to remove it, the problem then was what to do with the now vacant 8mm hole. A well known figure in the vintage wireless movement has disparagingly commented that the receipt of an amateur transmitting licence is accompanied by a presentation box of twist drills with which precious equipment could be disfigured. With the consequences of this wry observation very much in mind I now had to find an acceptable method of repair. On a blank unpainted chassis a repair section could have been welded in place but an approach requiring lots of heat was clearly impractical for assembled equipment. The repair method finally decided upon was similar but avoided extremes of temperature, being a tiny steel disc filed to be an exact fit in the hole. With the disc flush to the panel it was secured with araldite, and after a little black paint was applied with a fine sable brush the repair passes inspection although it is not invisible.

The broken coil former was sanded square and very carefully repaired with araldite while the ferrite tuning slug that had made a bid for freedom was replaced by a section from a donor transistor radio, araldited in place. Ferrite is very hard and cannot be easily cut in the conventional sense. The trick is to score around the circumference with a file and snap a piece off - nerve wracking stuff but I managed to cut the rod without it breaking in the wrong place and then secured it to the threaded brass adjustment stud. One of the spring clips used to hold the former in place was missing so a substitute was made from thin sheet steel liberated from a scrap computer power supply case and coloured to look like spring steel. It doesn't function as a clip but the coil spigot and wiring perform this function and it seemed unwise to needlessly increase the loading on a fragile repaired component.

The IF section only appeared to need tidying of wiring that had been disturbed earlier, dealing with the missing output transformer, and replacing the connector cable. While looking for trimmers for the RF unit I happened to notice that the output transformer of an incomplete Class D wavemeter looked identical. Although not the exact part number, testing showed it having similar electrical characteristics and could pass for original. With this in place further testing revealed something wrong, traced to a missing wire in an internal loom. Some cotton covered stock came to the rescue, coloured with a felt pen to look authentic and then loomed back into place

with some thick black cotton thread bought in a craft shop. With the IF section rebuilt, resistance checks between every valve pin and chassis confirmed an absence of potentially catastrophic errors, and it was powered up from a period bench supply. Initially it did not pass any signals from a signal generator but an open circuit screen resistor was the culprit and when replaced it all worked. The non original output transformer seemed not to affect performance. The BFO on – off switching is novel and had me puzzled at first as it was not at all obvious how the BFO was switched on and off. Close inspection of the 360 degree BFO tuning capacitor showed that one of the vanes was intentionally bent to short out the capacitor for 180 degrees of rotation, allowing it to perform the dual function of a pitch control and switch.

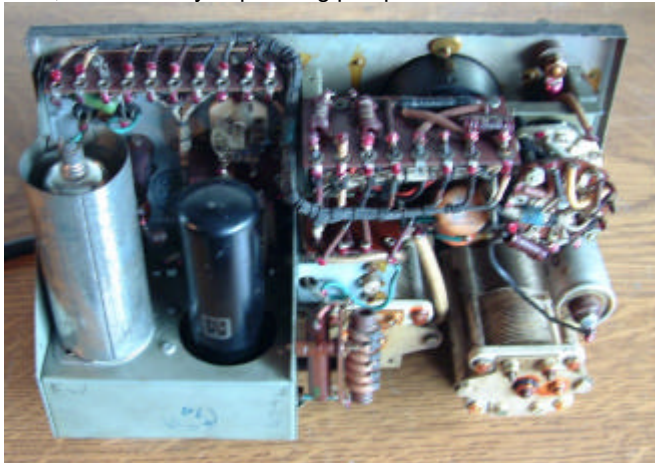
The B2 transmitter uses just two valves, a VT52 as a crystal oscillator and a 6L6 as a power amplifier. Like the receiver it is built around a thin steel front panel with a sub chassis for the valves, and fits into a lightweight metal container with corrugations to add stiffness. Crystal control only allows the transmitter to send on the frequency, or multiples, of the plug in crystal but would have been ideal for clandestine equipment of the time.

Beautiful simplicity - B2 transmitter with its two valves.

Two small modifications had been made to the transmitter, one allowed the power output to be further reduced for low power operations, and the other involved the addition of a small pushbutton to activate the oscillator and provide a signal for setting the receiver to the transmit frequency. The first modification was not needed and was easily reversed, but the second would leave a small unused hole in the front panel and as the function is useful it has been left in place for now.

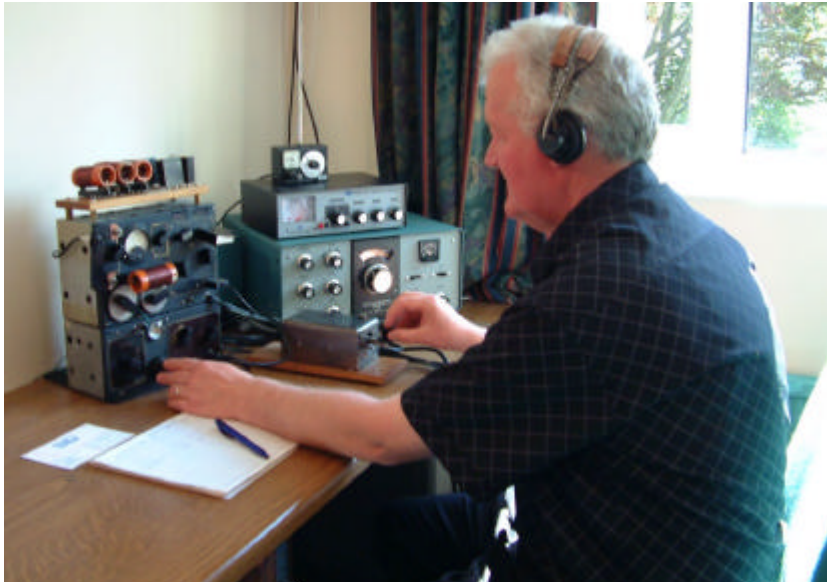
Transmitter and receiver in action with the Japanese Navy key. The Heathkit HW101 is usually used as the receiver but not on this occasion.
