The A41 No 3 – back in captivity

Antony Wedgwood GOTJD

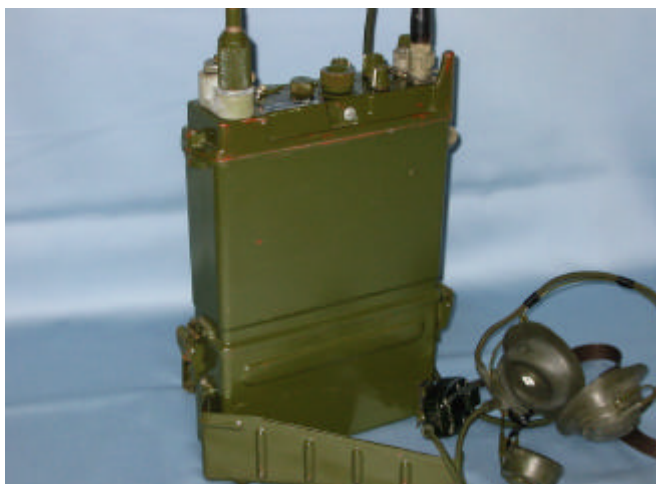
General View

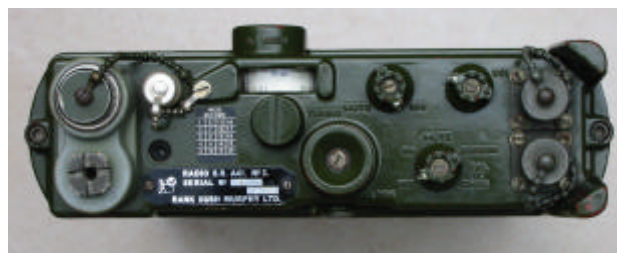
Control panel

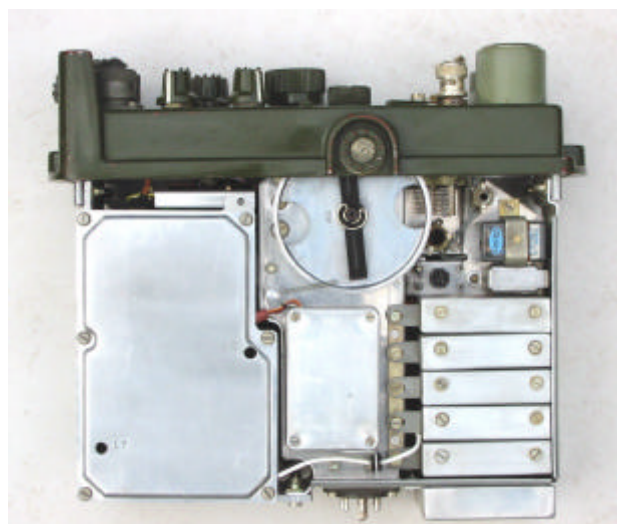
Top view as found

At first sight there didn't seem much wrong internally, although the PA transistor was obviously missing. Initial tests showed very little sign of life, however. I should have carried out a much more thorough visual inspection in the first place (some things are never learned) and it wasn't until I opened some of the diecast boxes that I discovered that the connections between practically every circuit board had been

unsoldered. There was no obvious reason for this, as the original wires were still in place; it was just that their ends were flapping about.

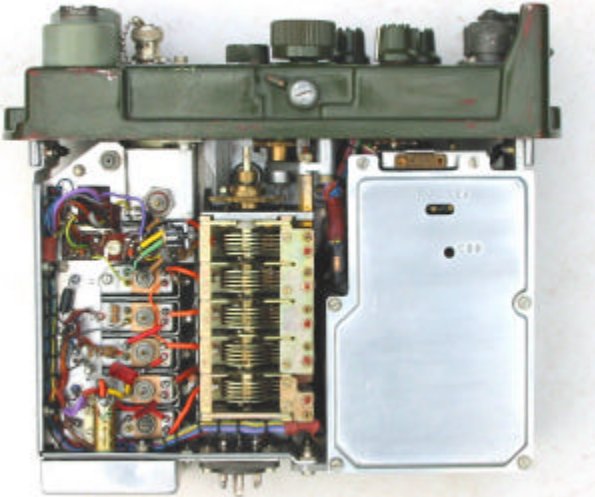
Bottom view as found
