An R107, Back from the Dead by Mike Hoddy, GOJXX

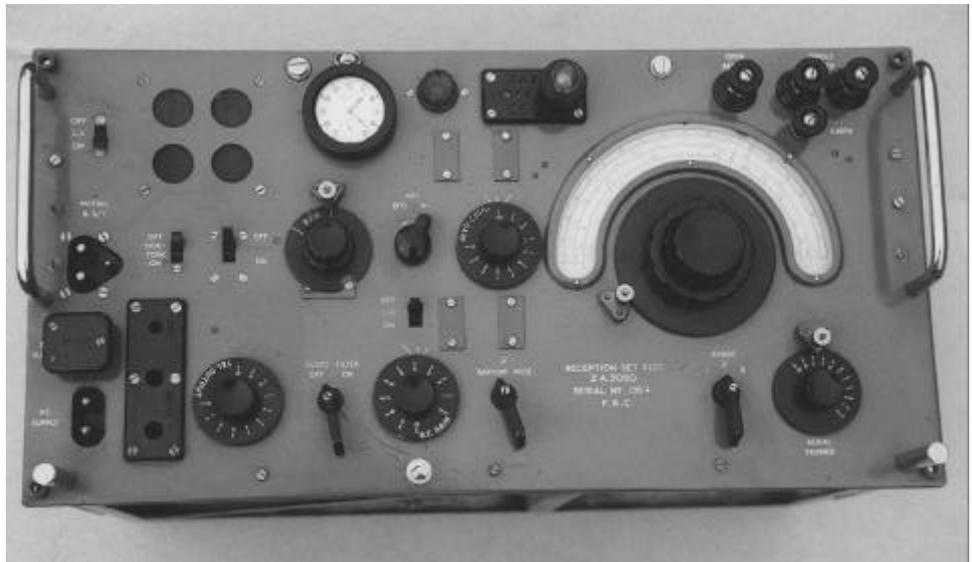
In terms of condition it was very poor as it had been stored in what must have been a puddle for about 25 years with heavy rust on the inside and underneath and first impressions was that it was truly 'dead' and the kindest thing would be to scrap it for bits and see if I could get a better example. I had been spoilt by my original one, as that was immaculate. The only thing going for it was that it was complete apart from one EF39, Relay and an original smoothing capacitor.

An obvious area that appeared to have sustained some damage was the front dial both Perspex front and the dial proper. In fact the dial was distorted so much that the screws holding the plastic in place had burst through. I was not hopeful that anything could be done and the chance of getting a replacement was very small unless I was very lucky indeed. The R107 is made in three separate units, RF, IF/AF and PSU/AF. Removal requires the de-soldering of the connections at the rear, removal of screws underneath and the knobs. That threw up a number of other issues in that the screws holding the knobs in place were totally damaged as though someone had tried very hard and when the grub screws had broken they had left them to rust in the holes.

On closer examination it was obvious that the Perspex front had been cracked down the centre but after cleaning it looked reasonable and I decided to leave that in place. The dial however was almost bent into a banana shape and I carefully removed the small nuts and bolts to lift off the panel. If anyone knows of a way of straightening a panel that is approx. 60-year-old plastic and has delicate coloured dial motifs attached without damage I would be pleased to hear. First thing I did was carefully clean off the worst of the filth that had accumulated with cotton wool and lukewarm water – no detergent as that seems to damage lettering for some reason – and then spray the printed side with a plastic coating so that at least there would be some protection.

Rather than risk total destruction I kept the panel in a warm airing cupboard under some weights for quite a while but that didn't work. In the end I replaced the backing sheet from the dial with white plastic and then re-fitted the original bolts with washers to pull the dial sheet back into place. This had the effect of limiting further damage, as the plastic is quite brittle and kept the dial flat.
